**Flood Control Project Maintenance
Levee Inspections**

Fall 2018 Levee Maintenance Deficiency Summary Report

Yolo County Service Area 6

Waterway			Bank	Unit Miles
Unit No. 01 Right Bank of Sacramento River at Knights Landing			Right	5.87
	Spring (March - May)	Summer (June - August)	(September - November) Fall	Winter (December - February)
Unit Maintenance Rating (Fall Only)			U	
Date of Inspection	3/15/2018 - 3/15/2018		9/28/2018 - 9/28/2018	
DWR Inspector	Zach Jojola		Zach Jojola	
Accompanied By	Casey Leibler Yolo County		Casey Leibler Yolo County	
	Elisa Sabatini Yolo County		Thomas Engler MBK	
	Thomas Engler MBK

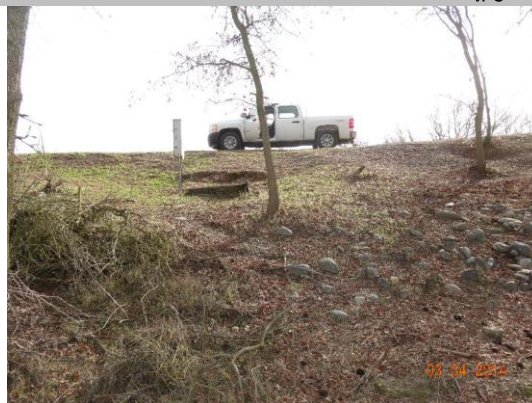
Photo 2 of 3 : UCIP_FA_2018_31927_58331.jpg

LM Start	5.47	Rating **	M	Issue No.	418 (cont)
LM End	5.47	Issue Type +	En	Location *

Rip rap along waterward slope.

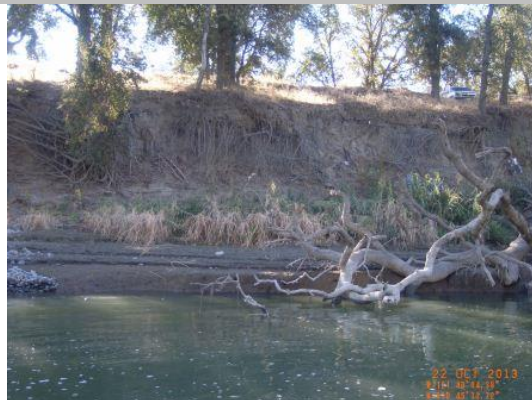
Photo 1 of 3 : FA_2018_NA0022_350_46_20181023_00130.jpg

2017 Site ID: SAC 83.9 R
Status: Eroding
2017 Field Notes: Fresh erosion on lower bank.
Site History: 2006 - Approximately 18 to 20 ft of bank near levee at the corner of the levee and the Freemont Weir. Vertical bank with undercutting/mass failure. 2007 - Staked at top of bank for monitoring. 2011 - Site has become significantly worse with more of the toe and lower bank eroded. Many trees have fallen since last year. 2012 - Site looks worse with more erosion around trees. 2013 - Additional erosion into the toe. 2015 - Site extended upstream about 500 ft to account for eroding bank. 2016 - Site continues to erode. Multiple trees appear ready to fall into the river.

LM Start	5.67	Rating **	M	Issue No.	46 (cont)
LM End	5.85	Issue Type +	Ma	Location *	WS

USACE 2013 Photo #1

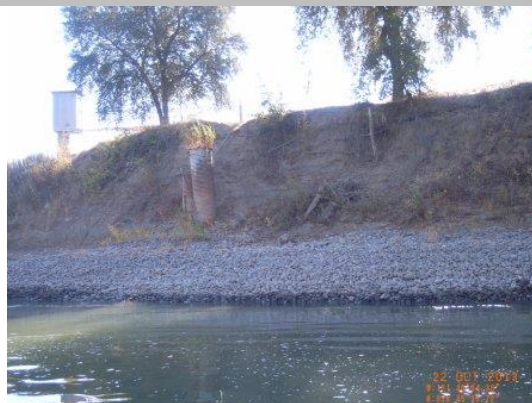
Photo 2 of 3 : FA_2018_NA0022_350_46_20181023_00131.jpg

USACE 2013 Photo #2

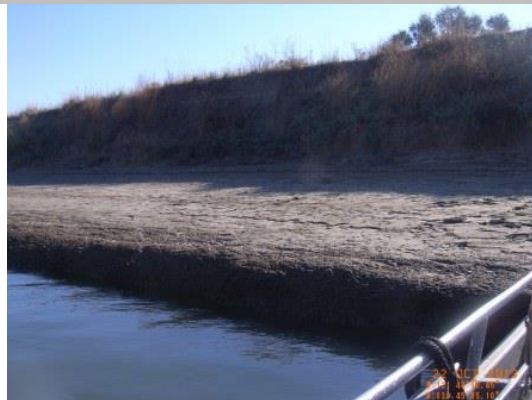
Photo 3 of 3 : FA_2018_NA0022_350_46_20181023_00132.jpg

Comment Code					
Inspector Comment					
2017 Site ID: SAC 83.9 R					
Status: Eroding					
2017 Field Notes: Fresh erosion on lower bank.					
Site History: 2006 - Approximately 18 to 20 ft of bank near levee at the corner of the levee and the Freemont Weir. Vertical bank with undercutting/mass failure. 2007 - Staked at top of bank for monitoring. 2011 - Site has become significantly worse with more of the toe and lower bank eroded. Many trees have fallen since last year. 2012 - Site looks worse with more ersion around trees. 2013 - Additional erosion into the toe. 2015 - Site extended upstream about 500 ft to account for eroding bank. 2016 - Site continues to erode. Multiple trees appear ready to fall into the river.

USACE 2013 Photo #3

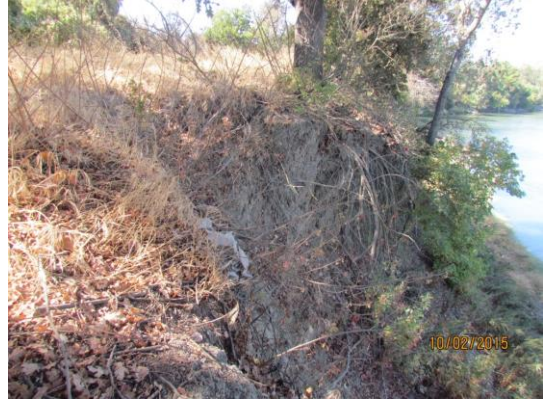
Photo 2 of 3 : FA_2018_NA0022_350_84_20180904_00042.jpg

LM Start	5.83	Rating **	A/W	Issue No.	84 (cont)	
LM End	5.83	Issue Type +	Ob	Location *	WS	
Category	Earthen Levee			GPS Latitude/Longitude		
				Start	End	
Item	Erosion / Bank Caving			38.758960 °	38.758960 °	
				-121.668200 °	-121.668200 °	
DWR ID	DWR_NA0022_01_f_2018_84					
Comment Code						
E1 : Note and monitor erosion site.						
Inspector Comment

View of the erosion on the waterward side of the levee looking upstream.
Fall 2015.

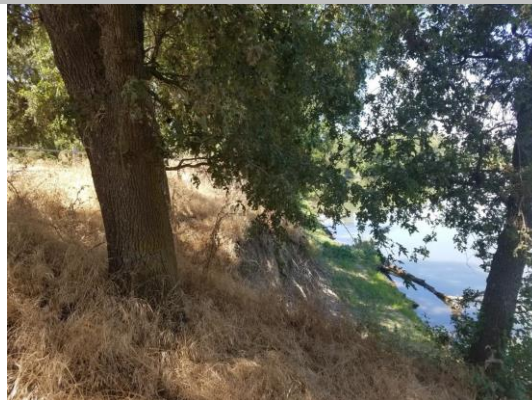
Photo 1 of 1 : LEVAL_FA_2018_490_4925.jpg

LM Start	5.85	Rating **	A/W	Issue No.	57
LM End		Issue Type +	Ma	Location *	
Category	Supplemental			GPS Latitude/Longitude	
				Start	End
Item	2017 Storm Damage			38.759100 °	°
				-121.667964 °	°
DWR ID	DWR_NA0022_01_f_2017_57				
Comment Code					
Inspector Comment					
Levee Evaluation Comments Description: Immediately U.S. of Fremont Weir Site ID No: 490 Site Designation: LMA-328 Repair Type: Erosion Rating: Serious Field Date: 7/27/2017 Notes: wide crown. Erosion not in prism. May be a new erosion pocket, but need to compare to fsrp data. Old veg still present.
